NASA TN D-5807

STATIC AND DYNAMIC FATIGUE BEHAVIOR OF GLASS FILAMENT-WOUND PRESSURE VESSELS AT AMBIENT AND CRYOGENIC TEMPERATURES

by Morgan P. Hanson Lewis Research Center Cleveland, Ohio 44135

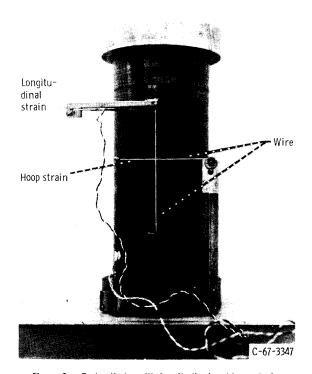
Figure 2. - Test cylinder with longitudinal and hoop strain measuring instrumentation.

Hoop and longitudinal strains were measured by means of strain-gage deflection transducers. The hoop strain was sensed by means of a 10-mil(0.25-mm) wire mounted circumferentially on the cylinder at the midpoint of the test section. The longitudinal strain was measured similarly between clips adhesively bonded to the cylinder wall. An installation is shown in figure 2.

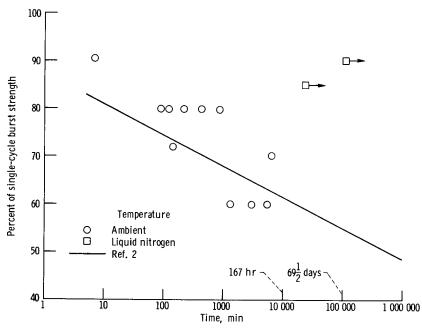
Figure 3. - Time to failure under sustained pressurization at various percents of single-cycle burst strength of aluminum-foil-lined FRP cylinders.

made ranging from 60 to 90 percent of the single-cycle burst strength. The results are compared with data from reference 2. Although scatter appears in the data of the present investigation, the general trend agrees favorably with the referenced results. Some of the scatter can be attributed to the variation in relative humidity and temperature that occurred during the testing period. At liquid nitrogen temperature where moisture is excluded, the only influencing physical factor should be the temperature because of the inertness of the nitrogen. In the two tests at liquid nitrogen temperature, no failures resulted in the FRP because of extended pressurization. Both tests were terminated because the test equipment malfunctioned. One cylinder sustained essentially constant pressurization at about 90 percent of the single-cycle burst strength for 88 days. The intent was to maintain a stable pressure in the liquid nitrogen environment. Maintaining this condition was difficult because of the problem in controlling the transfer of liquid nitrogen and pressurization with gaseous nitrogen. Figure 4 shows a continuous record of the temperature and percent of burst pressure of the cylinder pressurized at a nominal 90 percent of burst. After initial condensation of gaseous nitrogen and temperature stabilization, it was apparent that the system was not pressure tight, and, in one instance, a complete depressurization occurred. A preliminary pressure check of the cylinder at ambient temperature, however, disclosed no leaks in the cylinder. In two instances, the loss of liquid nitrogen caused the temperature to increase. Corrective

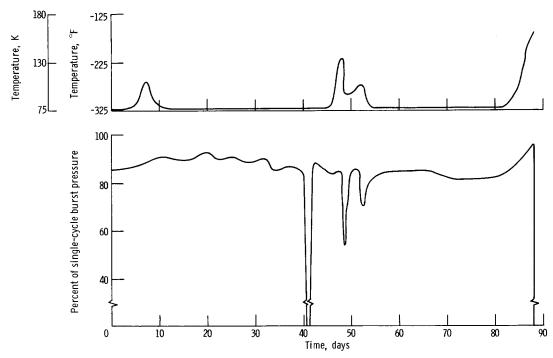
Figure 4. - Pressure and temperature profiles of static fatigue test in liquid nitrogen environment as function of time.

measures were taken, and the liquid nitrogen temperature was restored. The termination of both static tests in liquid nitrogen was the result of the cylinders bursting during unattended periods. The temperature-pressure record of one cylinder shows that a pressure rise resulted from the loss of liquid nitrogen. Although both tests were inconclusive in terms of static fatigue at liquid nitrogen temperature, both cylinders showed a significant improvement compared with the ambient static fatigue characteristics.

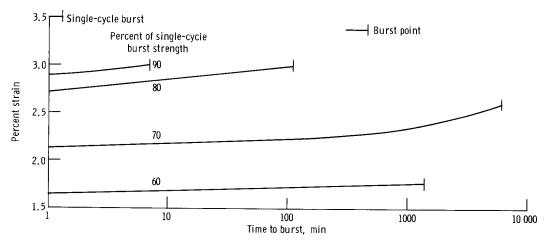
Figure 5. - Ambient temperature strain-time curves of aluminum-foil-lined FRP cylinders pressurized to various percents of single-cycle burst strength.

burst strength. The strain behavior is inconclusive because of variations in the results. However, it is interesting to observe that the static strain did not approach or exceed that of the short-time burst tests. Generally, it appears that no appreciable change in strain occurs above that of the initial strain. This has been observed in glass composites by other investigators (ref. 8).

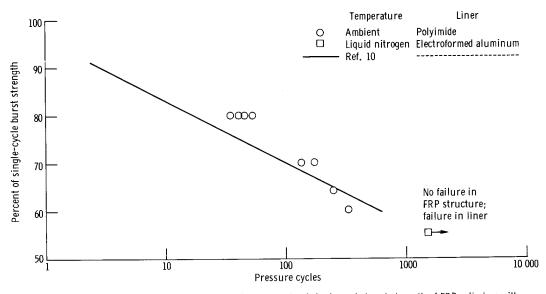
The results of cycling FRP cylinders at ambient and liquid nitrogen temperatures at various percents of the single-cycle burst strength are shown in figure 7. Polyimide-lined cylinders cycled to failure at ambient temperature show good agreement with pub-

Figure 7. - Pressure cycles to failure at various percents of single-cycle burst strength of FRP cylinders with polyimide liners at ambient temperature and electroformed aluminum liners at liquid nitrogen temperature. Cyclic rate, 2 cycles per minute.

lished data (ref. 10). In liquid nitrogen, the electroformed-aluminum-lined cylinder was cycled 1509 cycles at 55 percent of the liquid nitrogen burst pressure (approx 2.1 percent hoop strain) without failure to the FRP. However, extrapolation of the ambient temperature test results to the 55-percent level would predict failure in the FRP at ambient temperature.

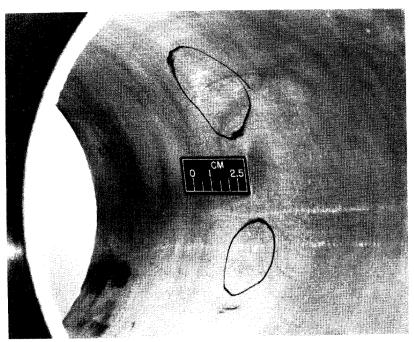
Attempts to cycle aluminum-foil-lined FRP cylinders to failure in liquid nitrogen were unsuccessful because of limited liner life. The seam area buckled under cyclic load and caused holes in the liner. A typical buckling failure is seen in figure 6. The seam problem resulting from the foil liner construction was eliminated by lining a cylinder with one electroformed aluminum liner, as described in the Materials and Experimental Procedure section.

Figure 6. - Tyical seam failure of aluminum foil liner.

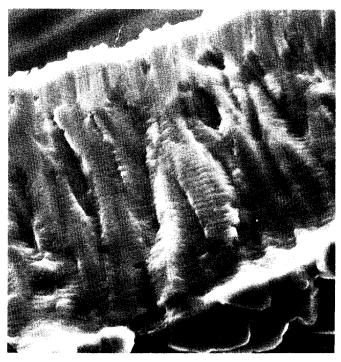
Within a few cycles of the termination of the liquid nitrogen cyclic test, it was observed that the constant cyclic rate of 2 cycles per minute was being extended. After 1509 cycles, the pump capacity could not maintain pressurization. Inspection of the cylinder after failure revealed no buckling or release by buckling of the liner from the FRP cylinder wall. Inspection by means of a fluorescent penetrant, however, revealed cracks in the aluminum. A photograph of the failed liner in place in the cylinder is shown in figure 8(a). A portion of the liner that was removed from the cylinder is shown in figure 8(b). The sample has been spread slightly to reveal the extensive frigue cracking. The direction of the cracking is primarily transverse to the hoop direction, indicating that the maximum principal stress in the liner was in the hoop direction. However, crack deviations from the longitudinal axis indicate the influence of a biaxial stress state.

(a) Fluorescent penetrant examination of fatigue cracks of electroformed aluminum liner attached to FRP cylinder.

(b) Section of electroformed aluminum liner removed from cylinder and expanded to show fatigue crack patterns. X10.

Figure 8. - Electroformed aluminum liner as fatigued by press, the cycling in Figure hitropen

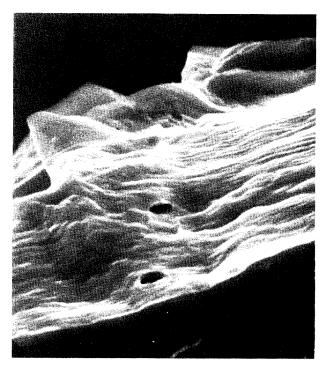
Figure 9(a) substantiates the conclusion that the liner failure resulted from fatigue. A scanning electron micrograph of the fatigue fracture surface reveals striations as a result of the crack propagation through the thickness of the liner. Surfaces of tensile fractures of electroformed aluminum (fig. 9(b)) and of wrought aluminum foil (fig. 9(c)) show different fracture phenomena.

(a) Fatigue fracture surface of electroformed aluminum liner material, $\,$ X1200.

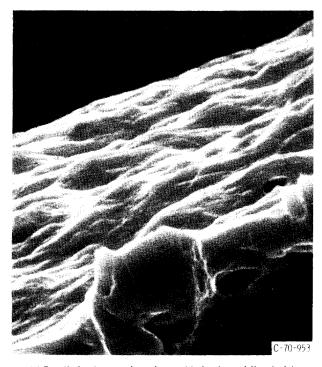
(b) Tensile fracture surface of electroformed aluminum liner material. $\times 2000.$

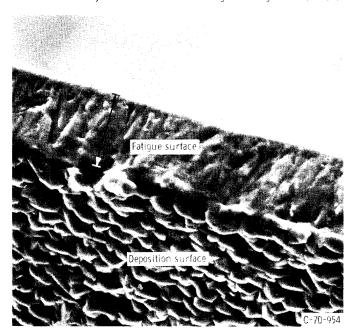
The electroformed aluminum liner and a portion of the FRP cylinder wall are shown in figure 10(a). A fatigue crack extending through the liner is shown with no evidence of propagation into the adjoining resin adhesive. It is also interesting to note the crack in the resin matrix that terminates in the crossply fibers.

(a) Section of FRP cylinder wall and liner showing liner fatigue crack. X250.

(b) Fatigue and deposition surfaces of liner material. X500.

Figure 10. - Electroformed aluminum liner material used as liner in FRP cylinder.
